**Final Report for
BMPs for Cranberry Farms Grant No. G0200278**

March 29, 2005

**Kim Patten
Washington State University Long Beach Research and Extension Unit**

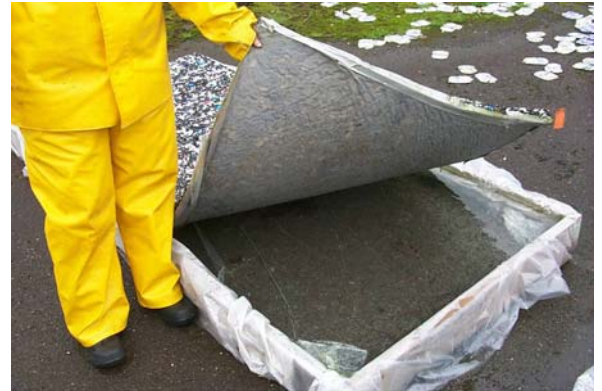
Floating filtration beds: A floating system was designed using a floating filter system from Environmental Fabrics, Inc. These 4' x 8' pads were filled with 1" recycled foam padding glued over a geotextile fabric cloth (see photo). Different amounts (56 and 113 g/m²) of powdered activated charcoal were filled into the loose cell of each pad. Since not enough pads were available to cover an entire sump, a simulated container monitoring plan was conducted. Containers holding the pad were made and filled with water. Diazinon was sprayed over the tops of several types of charcoal-loaded pads. Water quality underneath the pads was monitored over time. Results from this monitoring study were inconclusive. Over time, insecticides were detected under all the floating filters. Apparently with rain and wind and other activity there is a loss of insecticides off the filters into the water. It can be concluded that these floating covers are not reliable enough to work for growers. The site also picked up some off-site contamination from a nearby pesticide application event.

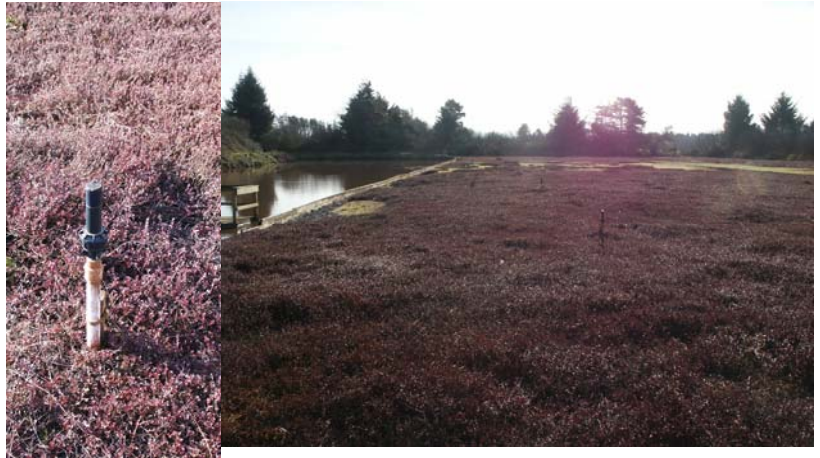
Partial Turn Sprinklers: Traditional cranberry sprinkler systems have very little flexibility for adjusting throw, backwash, and pattern. Therefore during a chemigation event it is hard to avoid contaminating surface water. Adjustable gear-driven irrigation sprinkler heads

however, can be adjusted for flow, throw, backwash, and pattern. Thus by switching over key trouble sprinklers in a bed that hit surface water it may be feasible to reduce offsite contamination. Such a system was installed at a grower site in 2004 to evaluate for their adaptation to an existing cranberry production system (see photo).

The sump adjacent to the sprinklers was monitored for pesticide loading. In addition, the persistence of the insecticide used during the event was monitored over time. Sprinklers were not properly adjusted for optimal use at this site and as a consequence they hit theater during the application event and the sump contained a small amount of Lorsban. There was a contained sump with no off-site movement and under those conditions it took longer than a month before the Lorsban was no longer detected. Although we failed to obtain any viable data to justify these sprinklers as a BMP, the growers who used this system, however, did feel that it was a very user friendly system that under some circumstances could be used to reduce surface water contamination.
